Special Publication

Power quality measurements: The third harmonic

by Jürgen Blum, Product Manager Power Quality Mobile

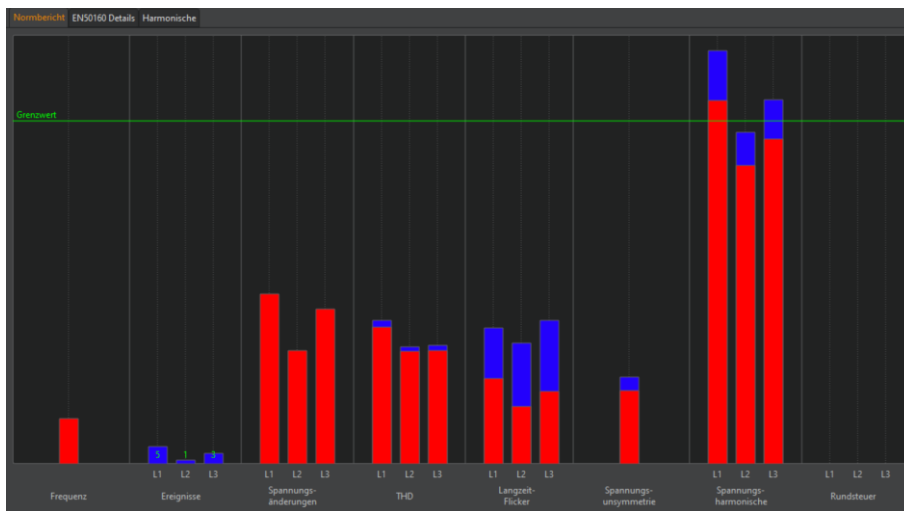
Figure 1 shows an evaluation generated from our WinPQ mobile software. This evaluation represents a one-week measurement according to EN 50160/IEC 61000-2-2 in the grid of an energy supplier at a hand-over point to a larger office building. Measuring all parameters according to EN 50160, more than 500,000 values are recorded, which are statistically processed by the WinPQ mobile software.

Since some devices in this office building are overloaded and fail after a short period, the tenant of the office building ask for an evaluation of the cause of this problem. In this diagram, all measured values are shown scaled to the compatibility values according to EN 50160. All bars that are below the limit line are uncritical. The values for voltage harmonics on phase L1 and L3 exceed the limit values and therefore further investigations should be conducted. However, this chart does not provide the required information to evaluate which frequencies have led to a limit value violation. Further data evaluation is required.

Figure 1: Measurement according to EN 50160/IEC 61000-2-2

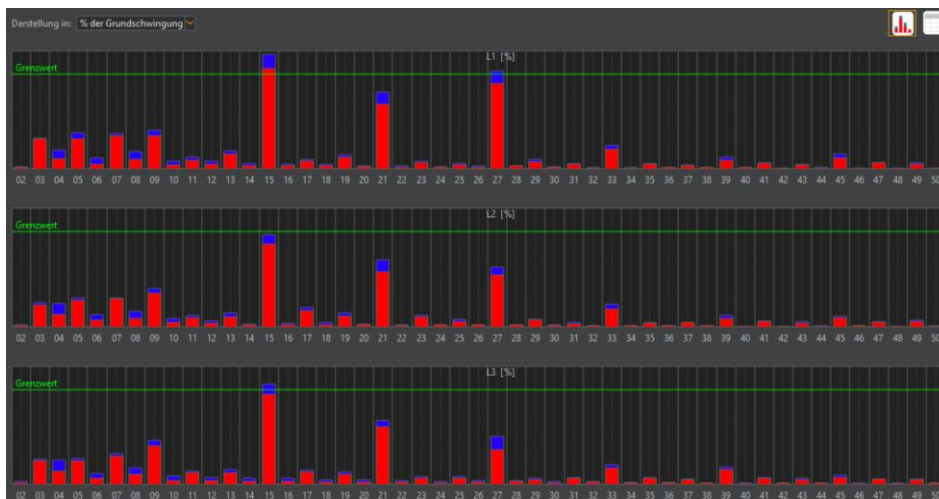
Taking a closer look at the limit values of the individual harmonics as in Figure 2, three peculiarities stand out:

1. The 15th harmonic is violated on phase L1.
2. On phase L2 the value is still just below the compatibility values.
3. The value of the 15th harmonic is violated on phase L3.

As already described in the previous article, the odd-numbered harmonics 21, 27 and 27, which are divisible by three, also stand out.

Figure 2: Display of the Harmonics

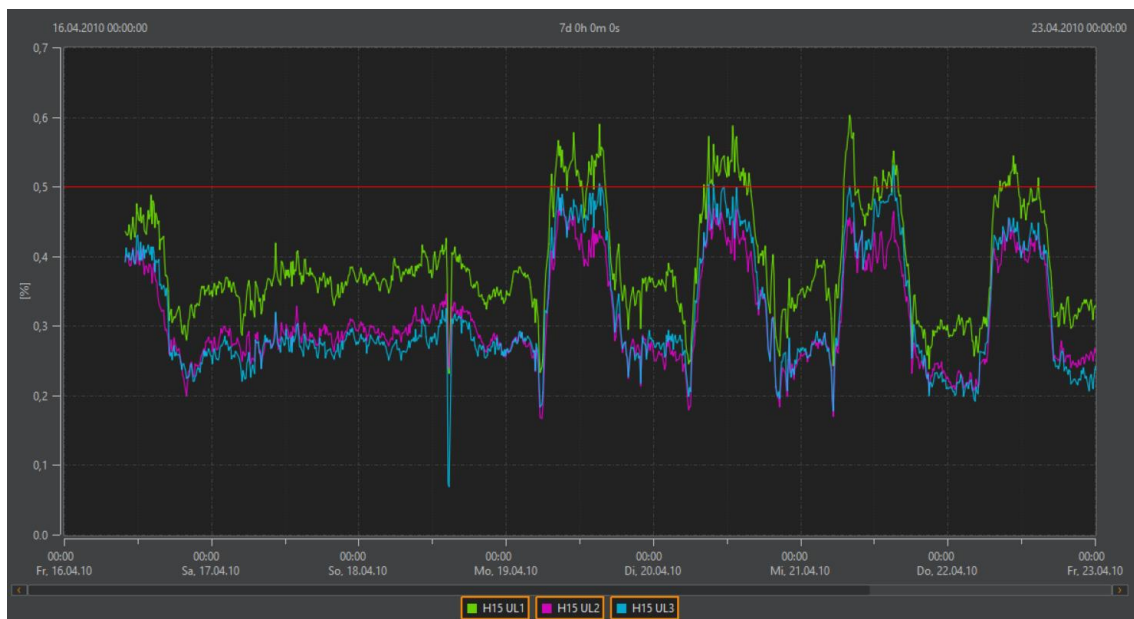
Scaling the data of the 15th harmonic to a week, the data suggest that the levels are at the same low level

during the weekend and during the night. From Monday morning the levels rise somewhat and fall again towards evening. By setting markers on the high and low points, the evaluation software shows that the levels are elevated between 06:50 and 16:40 - the typical office hours when employees are in the building.

Figure 3: Voltage curve and entered limit values in WinPQ mobile

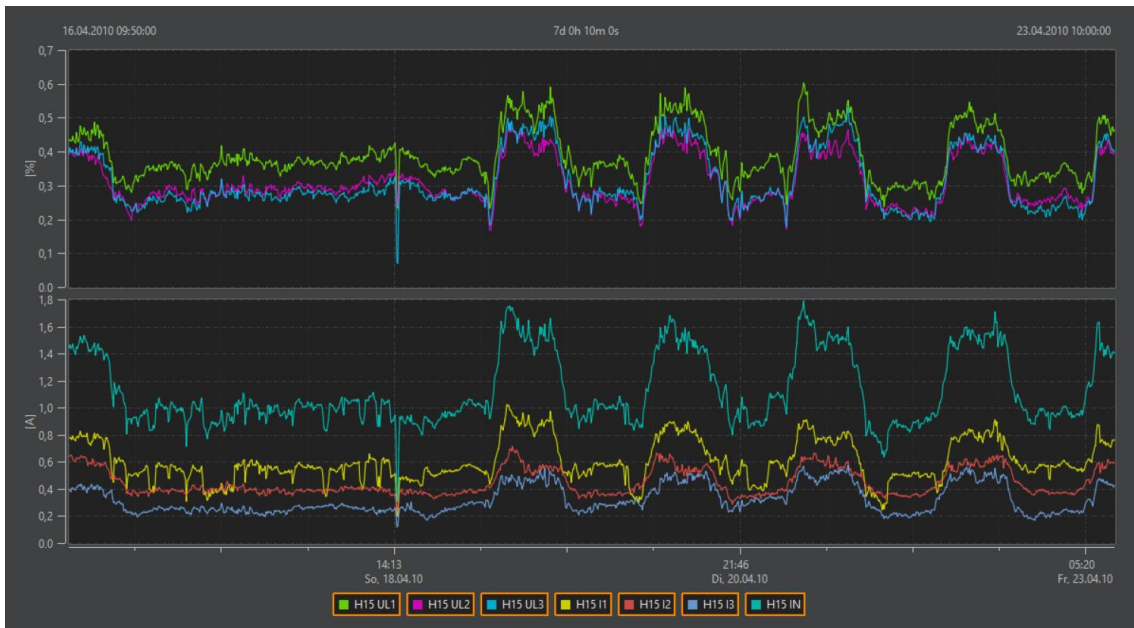
Figure 4 displays, that the neutral conductor is the highest load and corresponds approximately to the sum of the three phases. The 15th current harmonic, divisible by three, adds up on the neutral conductor. Taking a

closer look at the weekly profile, direct correlations with the voltage curve can be ascertained: The higher the current harmonics, the higher the voltage level in the grid. This effect can also be seen with other harmonics. Unlike the current levels, one cannot assume that the voltage levels will drop to zero, because the voltages or feedbacks are the sum of all the consumers working in the grid, and at the weekend a large number of consumers are certainly active. Even a transformer in no-load operation produces some harmonics. With view at the limit values, it could be said that they are not exceeded at night and on weekends. Only during operating hours in the office, when many single-phase consumers are operated, the limit levels are exceeded.

Figure 4: Voltage- & Current-Measurement

This measurement proved the customer's influence on the increased voltage reading of the 15th harmonic. Due to the many single-phase consumers in this office building, the limit value was exceeded. Actions were taken to improve the power quality in the customer's building.

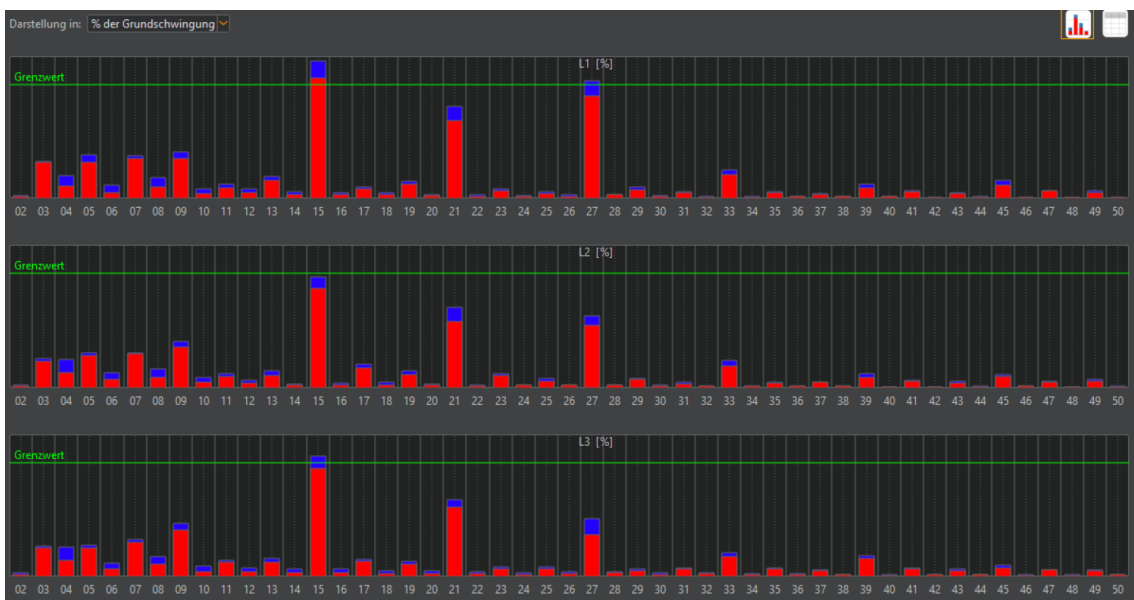
For users of the WinPQ mobile, there are also several different display options for the values. Figure 5, for example, shows the deviation of the measured value from the corresponding compatibility value in %. Of course,

Figure 5: Deviation of the measured value from the associated compatibility value in %

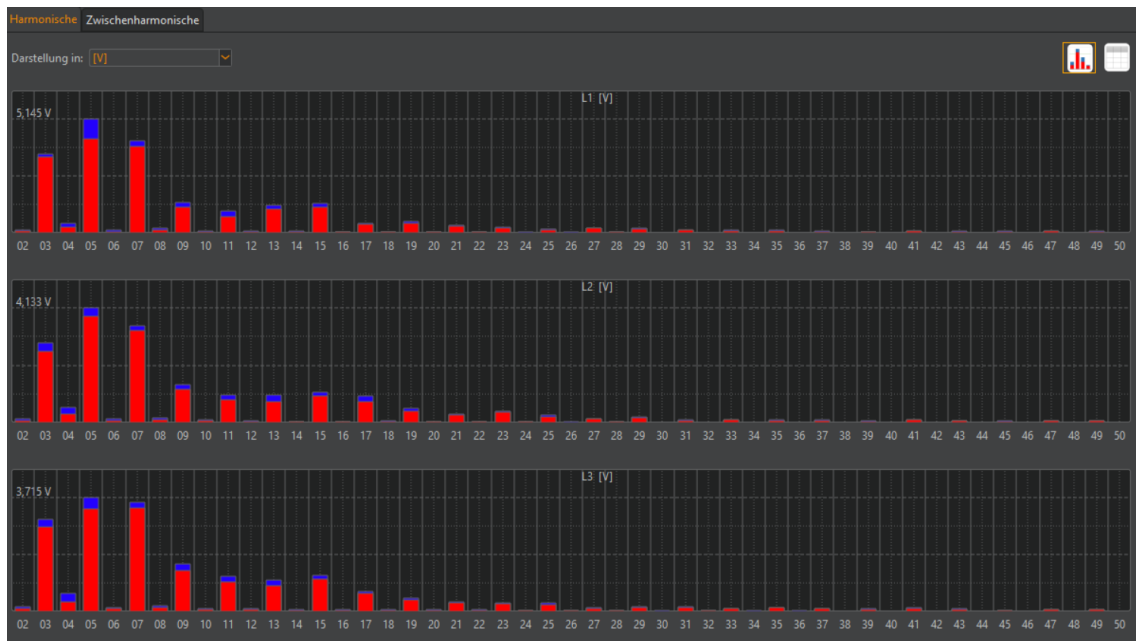
much smaller limit values apply to a 15th harmonic than to a 5th harmonic. Using the WinPQ mobile software, however, it is no problem to have the absolute values displayed in volts, as can be seen in Figure 6. In this figure, the 15th harmonic is not noticeable at all, but to note a limit violation, the user needs to know all limit values for each harmonic.

Figure 6: Absolute values of the harmonics
