Power Quality

Mains feedback interferes with protective devices

Residual current devices (RCD) trip because of supraharmonics caused by external grid consumers

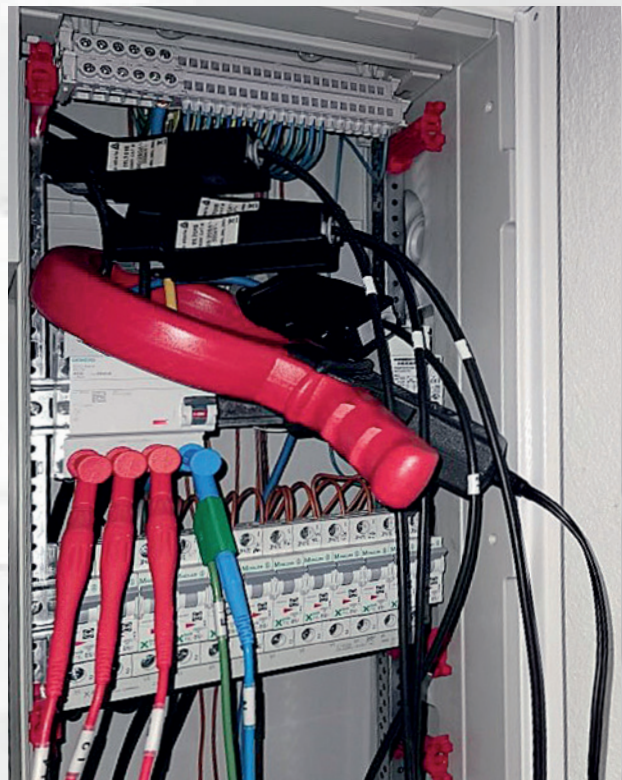
As displayed in Figure 1, the Power Quality network analyser PQ-Box 300 from A. Eberle is used to measure in the sub-distribution of the photo studio. The black current clamps are used for the conductors L1, L2, L3 and N record the currents via our RCD, while a fifth current clamp (red) additionally records the differential current. The differential current is the sum of the three phase currents and the neutral conductor and thus the current that is also evaluated by the RCD and the cause for the tripping.

At any time, the sum of the instantaneous values of the currents L1, L2, L3 and N should add up to the value of 0. The resulting differential current, recorded using the the fifth current clamp, thus corresponds to the current flowing the earth as fault current or leakage current. The voltages were connected to the output of the RCD via magnetic gripper, as shown in Figure 1. This magnetic gripper are quite convenient and quick to fit in any installation, as the screws of circuit breakers are always ferromagnetic, and thus magnetic taps can be adapted very easily and in a few seconds.

Figure 1: Connection of current clamps L1, L2, L3, N conductor (black mini current clamps), a differential current clamp (red) as well as the voltage measuring leads via magnetic taps (bottom, blue and red), connected to the power quality analyzer PQ-Box 300

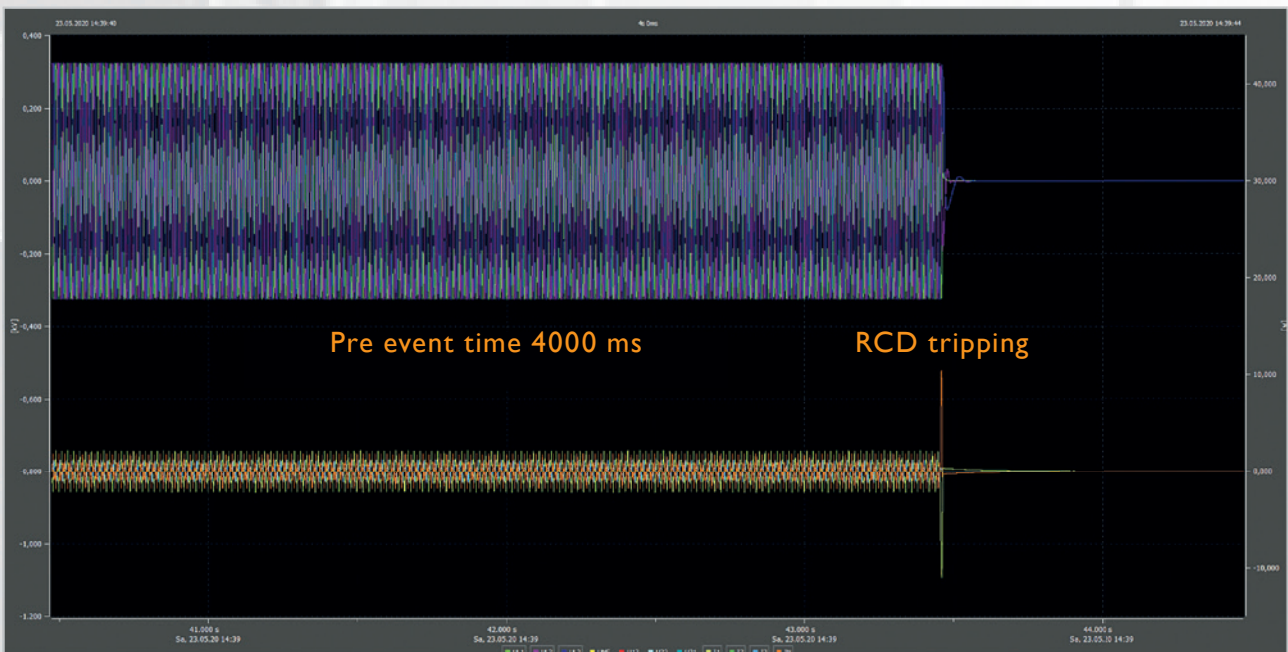
Usually, power analysers record a large post-history as a result of an event. In this case, however, the measuring device only receives its trigger pulse at the end of the disturbance and at this point, for the evaluation it is interesting to have a history as long as possible. High-quality power analysers keep oscilloscope images in a fast RAM for a long period, even if no set limit value is exceeded. Figure 2 shows one of these events.

Figure 2: Oscilloscope image of voltage L1, L2, L3 and currents L1, L2, L3, N-wire over 4000 ms recording duration with long prehistory and event at end

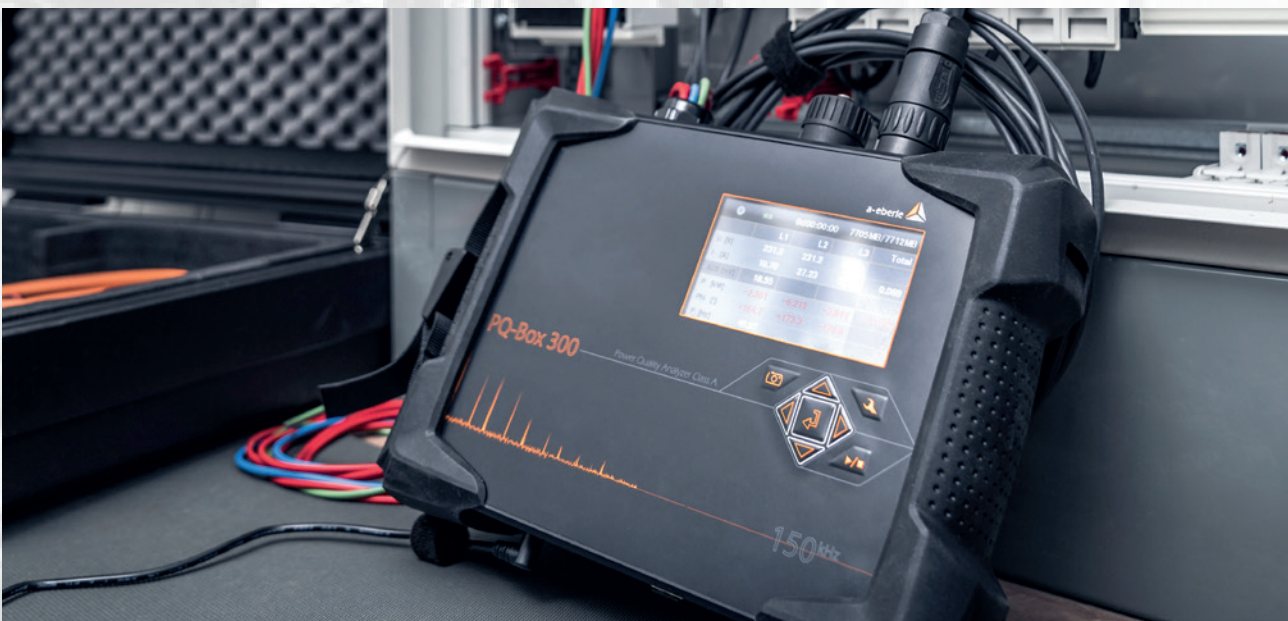
Figure 3: The PQ-Box 300 in action

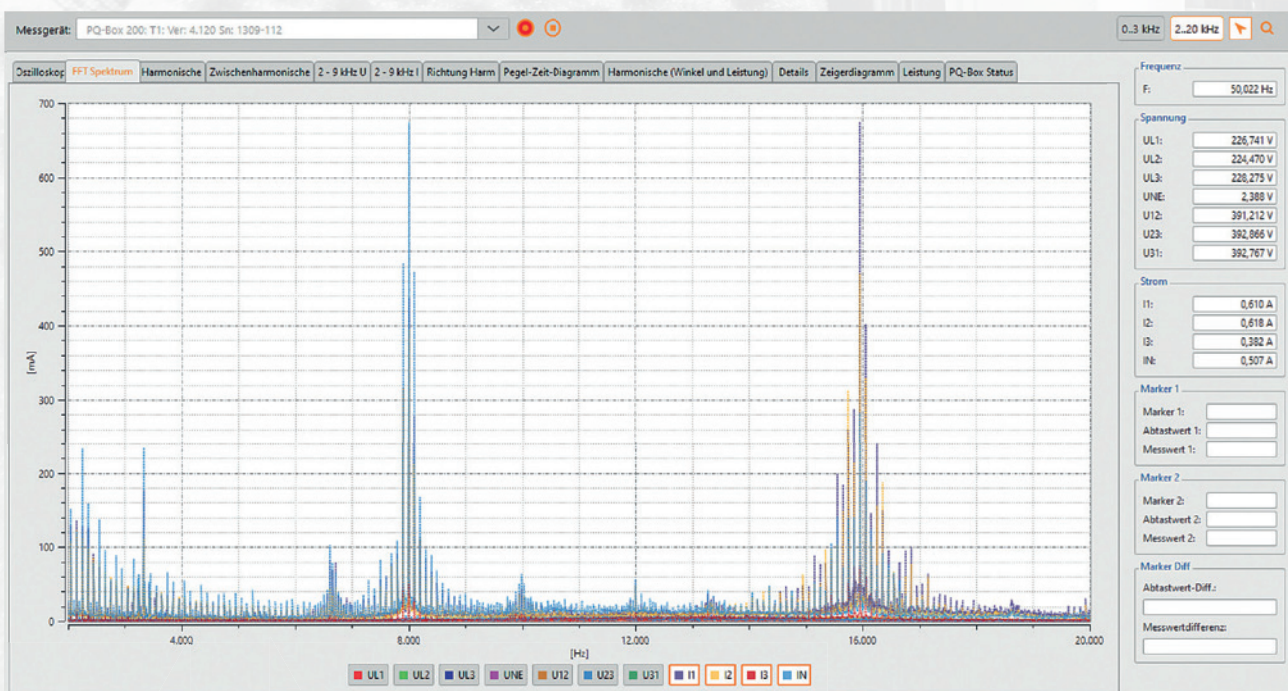
The frequency spectrum can be calculated from the sampled values shortly before the RCD is triggered using an FFT (Fast Fourier Transformation) analysis. In general, a measuring device can only calculate the spectrum up to a maximum of half the sampling rate. The PQ-Box 300 can calculate the spectrum to up to 170 kHz. The frequency analysis of the voltages and currents recorded during the fault show frequencies at 8 kHz, 16 kHz, 24 kHz and 32 kHz before the RCD tripped (Figure 4). Using the gathered data, the search for the cause continued. These frequencies are not generated by any consumer in the photo studio and must therefore be introduced into the electrical grid from the outside. In addition, the RCD tripped even when all the circuit breakers were switched off.

Note: Most clamp ammeters as well as simple mains analysers' usually only measure up to 2 kHz – thus the leakage currents that occurred here would not be measurable and would therefore often not be noticed.

Figure 4: FFT analysis of the currents from DC to 20 kHz – mains repercussions are clearly visible at 8 kHz and at 16 kHz with nearly 700 mA

The high frequencies of 8 kHz and their multiples can only be generated locally in the low-voltage network. It cannot be assumed that these high frequencies are transmitted via a transformer. Thus, the search was limited to this building, which is equipped with its own 400 kVA transformer. On the ground floor of the same building, a production plant with some inverter-controlled drives is located. From these plants, the high frequencies are emitted into the grid via the plant current.

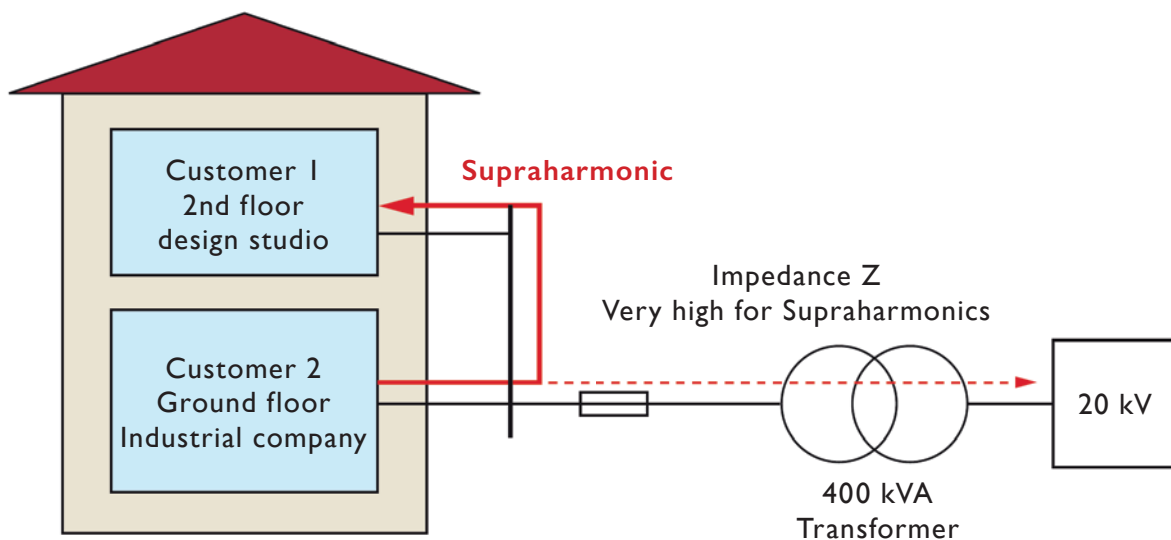
Since the transformer (X_L) of the building has a high impedance for high frequencies (see the commonly known formula 1), these introduced interfering signals of 8 kHz and their multiples usually seek other consumers nearby with a low impedance. These are mainly devices with built-in capacitors, such as switching power supplies. Formula 2 indicates this state (the imaginary components are left out for simplification):

The inverter-controlled drives on the ground floor generated mains feedback in the frequency range of 8 kHz and multiples thereof. These levels will hardly flow in the direction of our 400 kVA transformer because it has a high impedance for high frequencies (see formula 1; Figure 5). These clock frequencies seek out to other consumers in the vicinity, which have a low mains impedance for these frequencies. In this case, a current flows via the outer and neutral conductors towards the consumer.

Figure 5: Scheme of superharmonic propagation in this building.

- Installation of a mains filter directly in front of the sub-distribution of the photo studio on the 2nd floor
- Installation of a mains filter at the source of the mains feedback on the ground floor
- Replace the RCD with a suitable type for these mains conditions

Since we also wanted to avoid interference from other units in the building, we additionally decided to install a mains filter in the supply line of the company causing the interference on the ground floor. This eliminates the high clock frequencies directly at the point of origin.

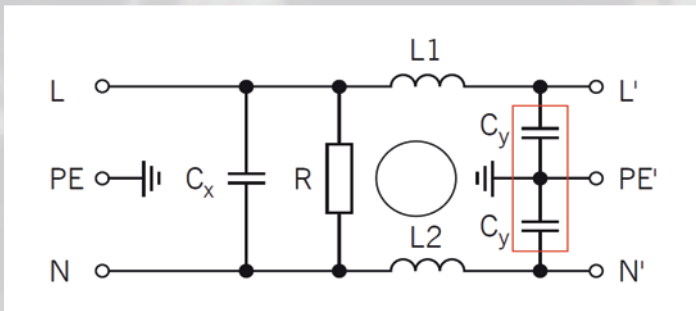
The mains filters in the various consumers of the photo studio generate leakage currents to earth. All consumers must have such EMC filters to obtain the CE mark. Since switched-mode power supplies themselves also produce conducted interference, these devices must be connected to filters. Most times, simple passive components such as current-compensated mains chokes and X/Y capacitors (Figure 6) are used.

Figure 6: Example of X and Y capacitors in the input of a switched-mode power supply; in this case, the Y capacitors are critical.

As it is not clearly defined, which position the outer conductor and the neutral conductor take when connecting a single-phase consumers via a Schuko socket, filters are found on both conductors: outer conductor to earth and neutral conductor to earth. The resulting leakage currents are predominantly capacitive, while fault currents have a high ohmic component.
